# FIELD TRIP GUIDE BOOK

## THE SECOND WORLD LANDSLIDE FORUM

**Field trip to Orvieto,  
Civita di Bagnoregio and Ancona**  
an itinerary through landslides,  
cultural heritage and innovative  
solutions for monitoring

G. Delmonaco - G. Scarascia Mugnozza - P. Tommasi

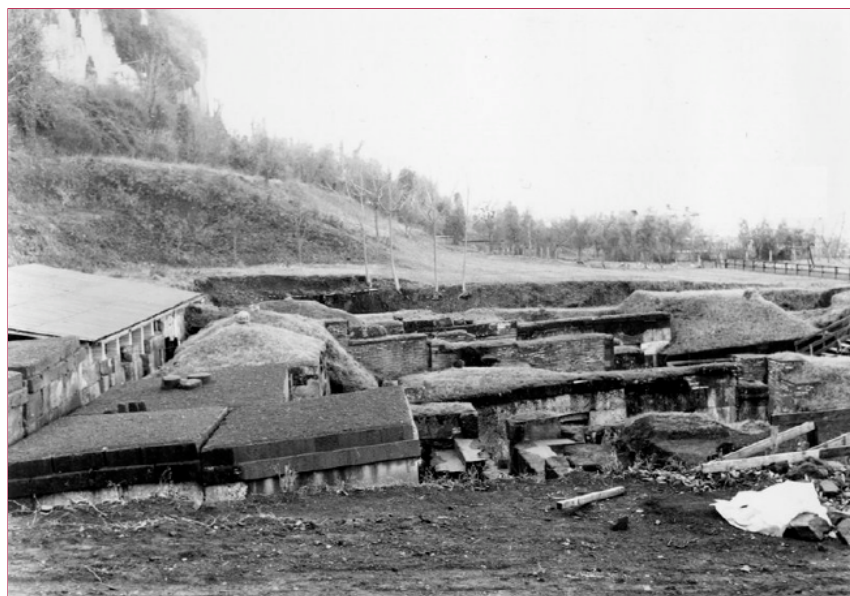
Fig. 4. Backward-tilted Etruscan dice-tombs of the necropolis of "Crocifisso del Tufo" on the northern slope (Stop 2). The terrace in the foreground is horizontal

as demonstrated by the backward-tilted Etruscan tombs of the necropolis of Crocifisso del Tufo (Fig. 4, Stop 2). Otherwise they progressively and pervasively fracture until collapse.

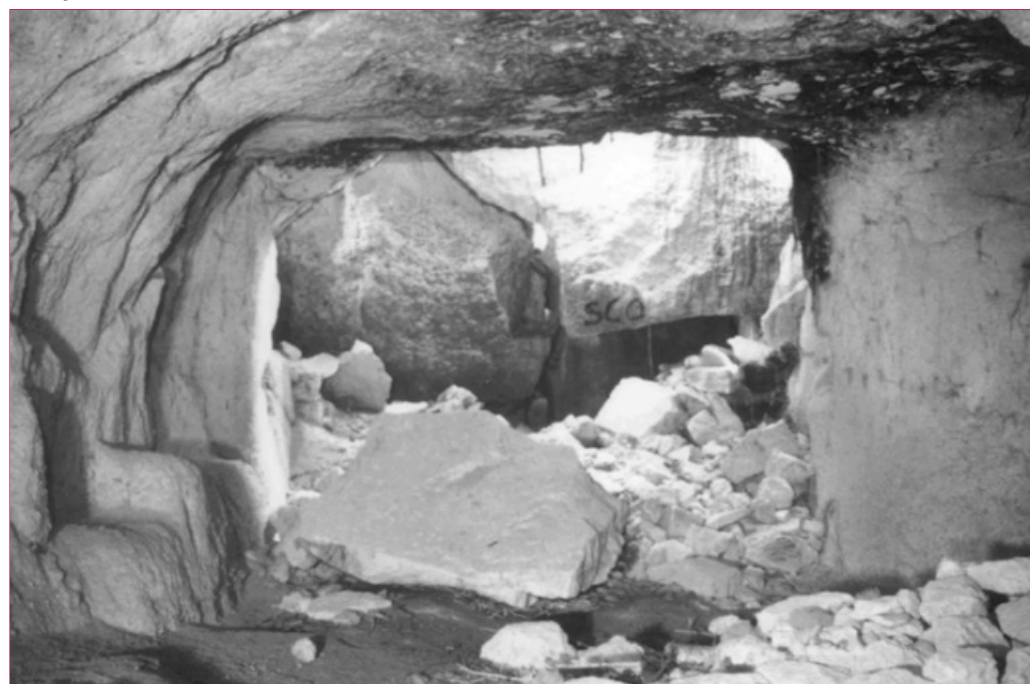
Fig. 7. Picture of a vault collapse in an underground cavity close to the cliff wall, near the St. Francis (o San Francesco) Church (Stop 3) taken before the reinforcement and rehabilitation works.

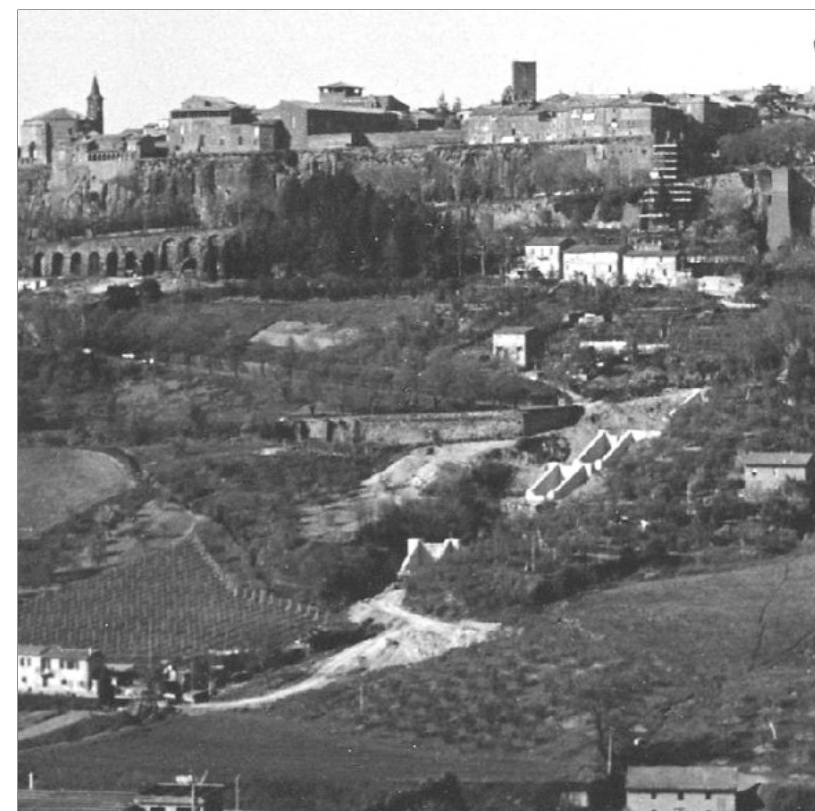
Fig. 9. View of the Salto del Livio Gully (southern cliff) during the regulation works (1985)

- elimination of uncontrolled water discharge onto the clay slope;
- elimination of leaks from sewer and aqueducts, which had increased infiltration in the pyroclastic slab;
- regulation of hydraulic regime of gullies and stabilization of their banks (**Fig. 9**);
- drainage in critical areas of the slope through horizontal drains drilled from shafts.

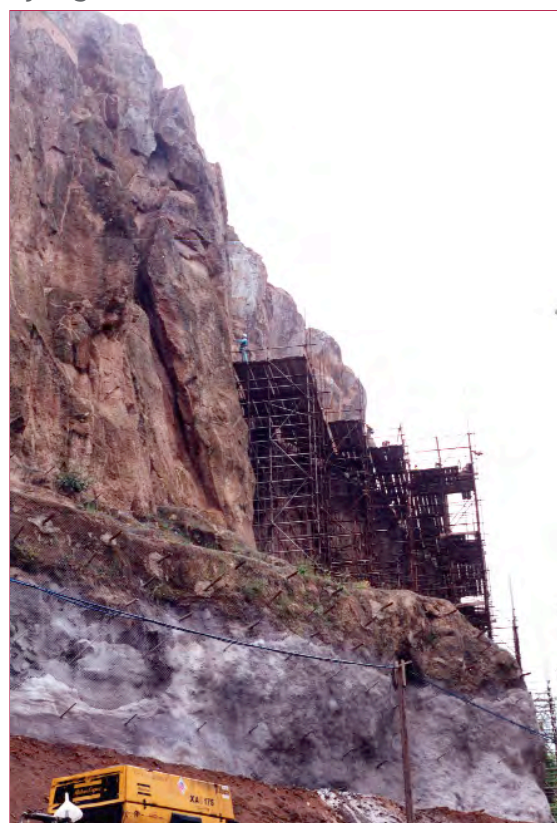
Fig. 10. Works for the reinforcement of the northern cliff. Passive bars are visible in the slightly cemented pyroclastites and fluvio-lacustrine sediments at the cliff base. Scaffolding for drilling and installation of pre-stressed tendons and passive bars are visible on the cliff. Formed by lithic tuff. In the foreground a potentially unstable large wedge anchored on the rock mass is visible.

Stabilization of the cliff was carried out through a virtually systematic reinforcement of the shallow portions of the rock mass by means of passive bars and anchoring of the potentially unstable wedges by means of moderately pre-stressed tendons (**Fig. 10**). A major task for the future will be the maintenance of the control measures whose decay was described in the past by authorities in charge of the preservation of the hill.

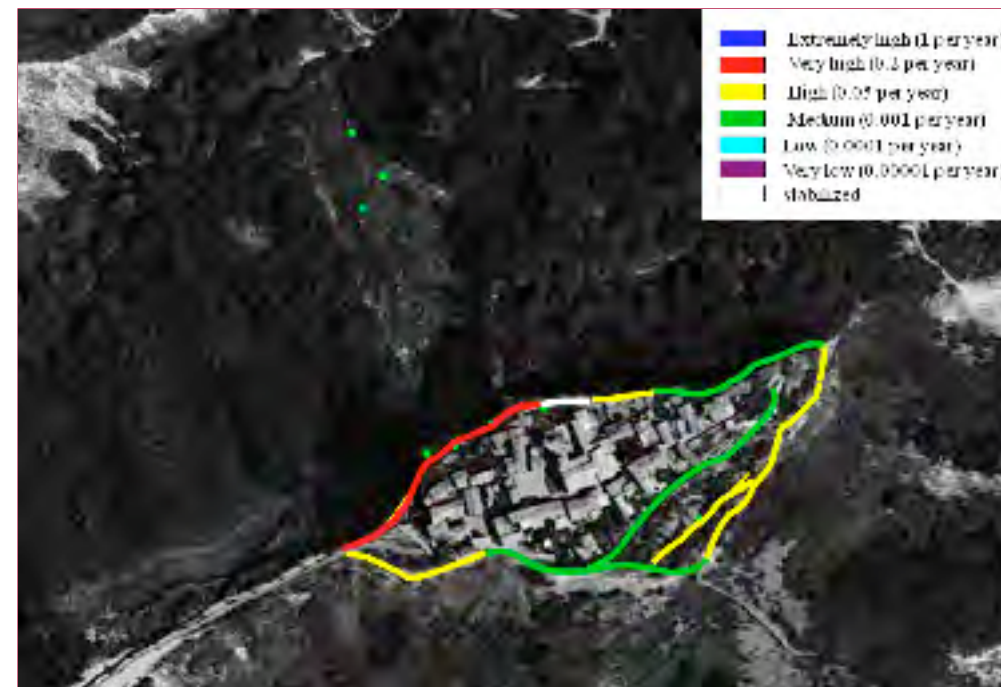
Fig. 16 - Hazard map of the Civita di Bagnoregio top cliff. Return period is based on Fell (1984) classification (modified).

A monitoring system was installed in March 2002 and mainly focused to the analysis of deformations in the northern cliff. The system includes: 1 inclinometer (equipped with TDR), 1 piezometer, 1 3D extensometer, 2 sub-horizontal multi base bore-hole extensometers, 3 cable extensometers, 1 crack gauge, 1 meteo-climatic station, GPS network, rock noise measurement and a ground based radar interferometer (**Fig. 15**). Slope stability conditions were also analysed with FLAC. Three main areas, displaying a critical safety factor, were analysed: the retrogressive area of Caven Grande, affected by the large rock-slide of 1993; Casa Greco where the open failure is reducing the shear strength of the cliff and the lower part of the cliff where the deposition of tuff debris laying on the clay bedrock can generate debris flows. According to historical evidence of landslides and actual stability condition of the cliff a hazard map, based on landslide return period (Fell, 1984) was produced (**Fig. 16**).

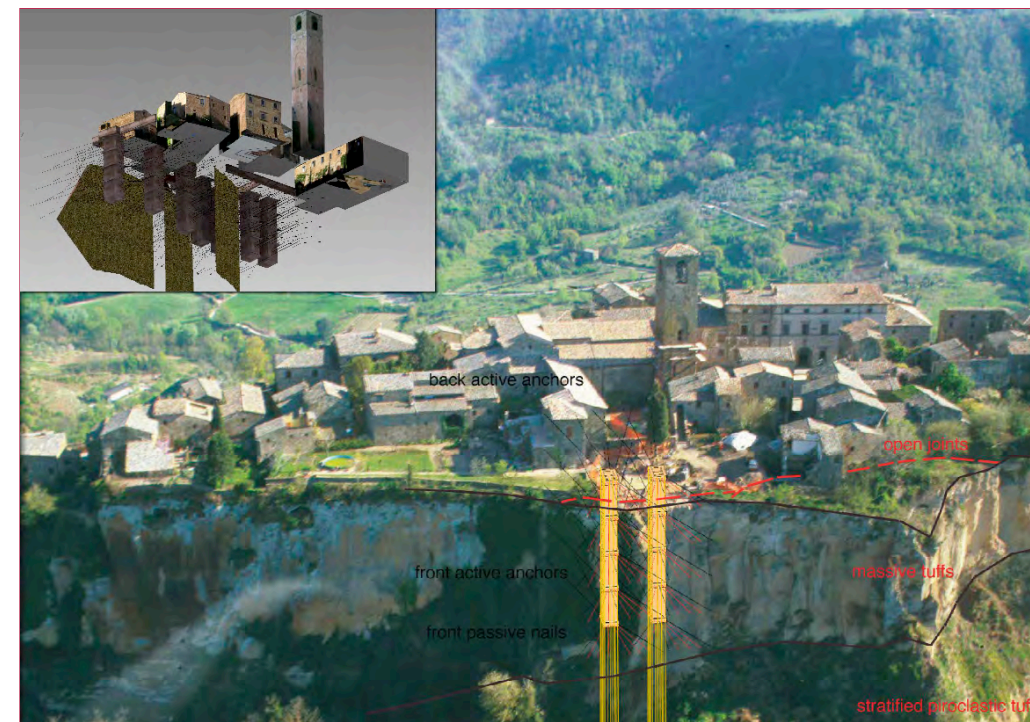
Fig. 17 - Low visual impact interventions and 3D-rendering of the mitigation works (upper left)

project is the result of an understanding of the evolutionary mechanisms of cliff movement identified by the geological and technical studies carried out over the past twenty years (Fig. 17).

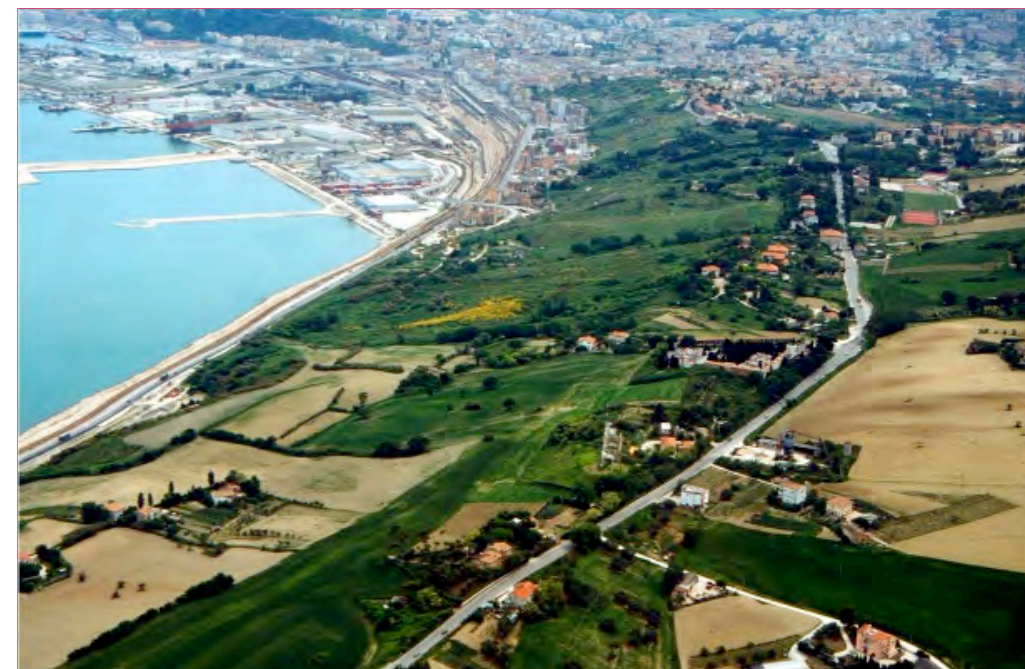
Fig. 18 – Aerial view of the Great Landslide (1982) of Ancona towards the seafront

On December 13<sup>th</sup> 1982, a large and deep landslide (the Great Landslide of Ancona city) reactivated along a slope located westward of downtown (**Fig. 18**), interrupting the State road "Flaminia" and the national railway and damaging many buildings (AA.VV., 1986; Cotecchia, 1997). In the late '90s a preliminary plan for designing remedial measures and consolidation of the landslide started, but it was concluded that consolidation was difficult to be afforded, both due to very large expenses and to a very significant environmental impact. It was then decided "to live with the landslide", reducing nevertheless the risk for people living there. This was achieved through the realization of drainage systems (both deep and superficial) and the set up of an Early Warning System linked to an Emergency Plan managed by the Municipality of Ancona city: these are based on an integrated and

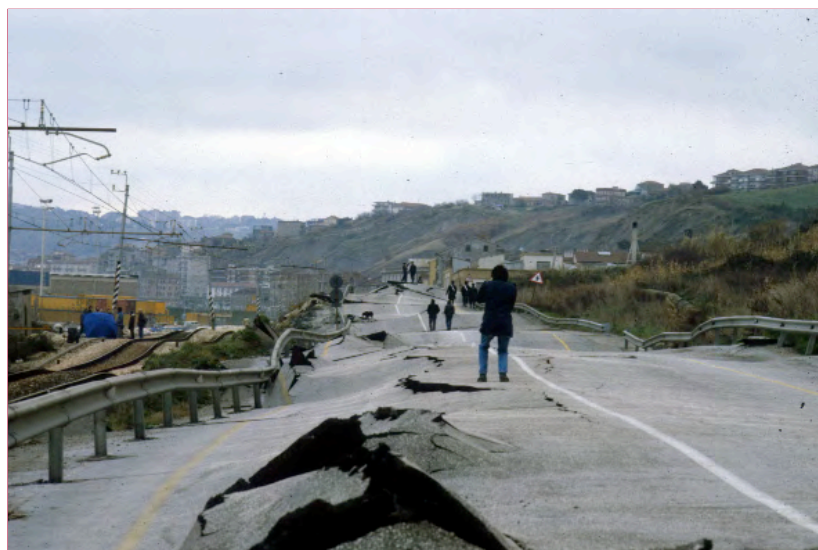
Fig. 19 – An image of the landslide toe soon after the 1982 event.

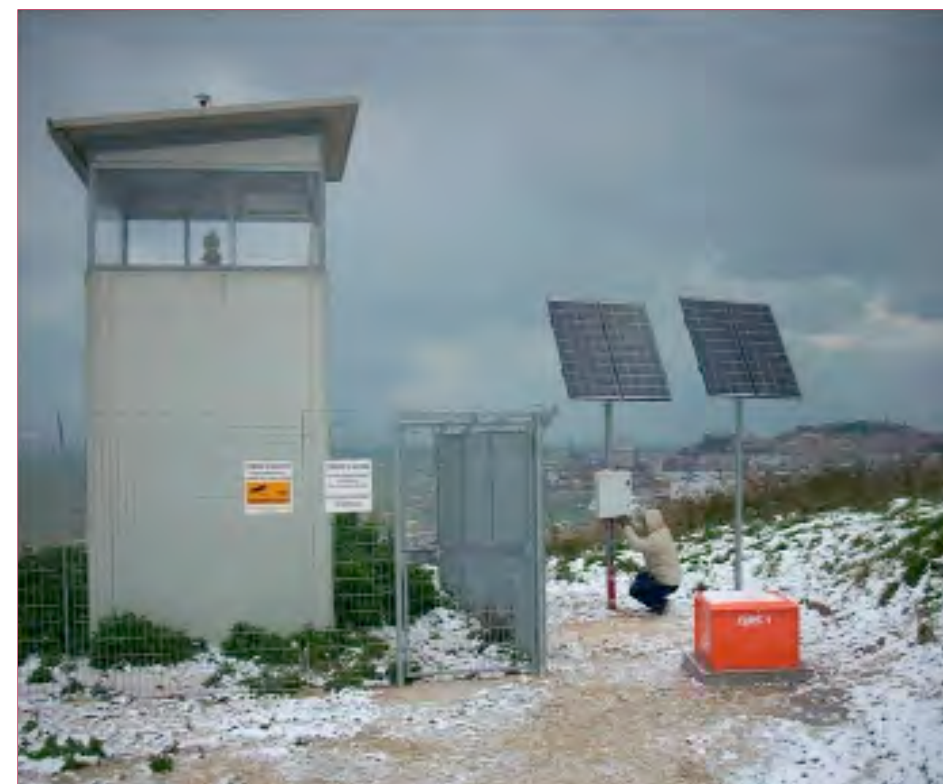
Fig. 21 – View of a total station within the landslide

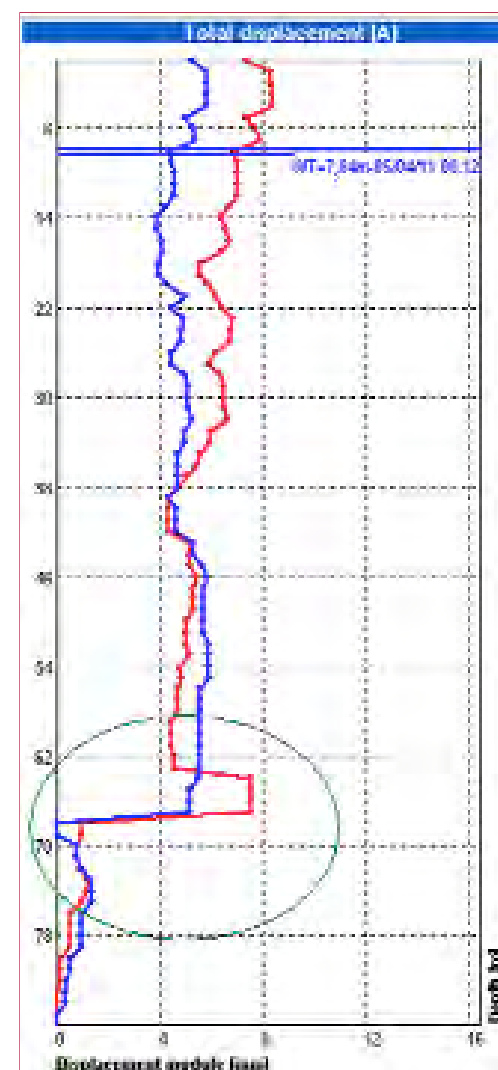
Fig. 22 – Plots of displacement measurements recorded through the DMS

A geotechnical monitoring system DMS is also currently operating (patents and trade mark CSG-Italy); it is made of 3 boreholes (100 m), all instrumented with a Dynamic Modular System column (Fig. 22).

Each column is formed by 85 biaxial Inclino-metric modules (range  $\pm 20^\circ$ , resolution 0.01), 2 Piezometric sensors (range 200psi resolution 0.01), 85 temperature sensors (range 0-70°C, resolution 0.1) for a total active length of 85 m (excluding the first 10 m and the last 5 m). DMS has been preassembled and installed in site forming an instrumented column, like a spiral cord, connecting modules and electronic boards for data collection and transmission. The modules are linked by special 2D/3D flexible joints that allow strong, continuous adaptability to bends and twists of the boreholes, whilst rigorously maintaining the orientation with respect to a reference system defined during installation.

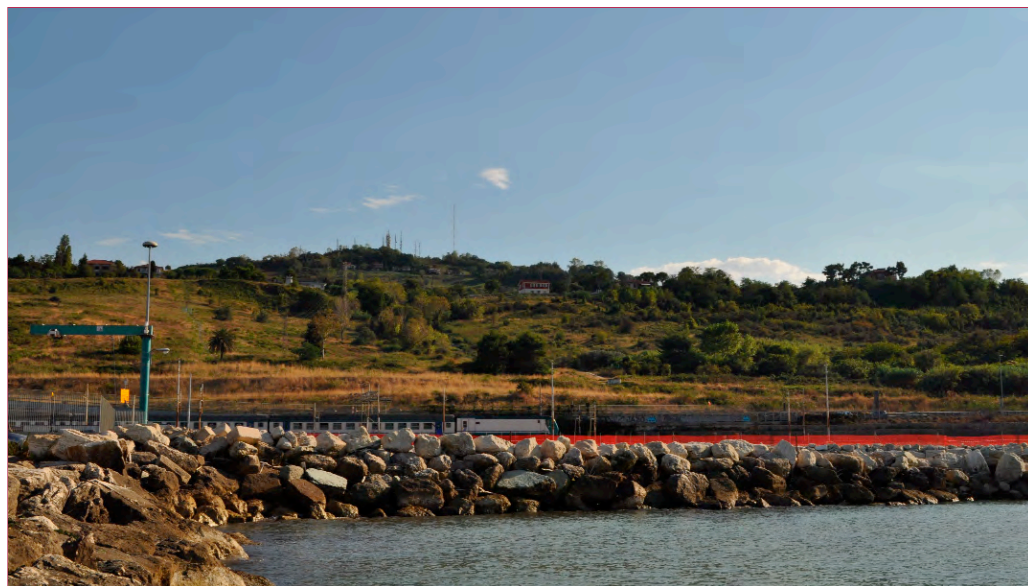
Fig. 23 – View of the landslide from Marina Dorica (Stop 1)

From the port of Ancona it will be possible to have a spectacular front-view of the Great Landslide of Ancona (Fig. 23). The geological and geomorphological setting of the slope will be introduced as well as the geotechnical model of the great landslide. In this place it is also located one of the stations belonging to the Monitoring Network.
